Waste Heat Boilers: FFS Case Histories

Session: Fitness for Service

API Inspectors Summit
Galveston Texas
January 27-30, 2009

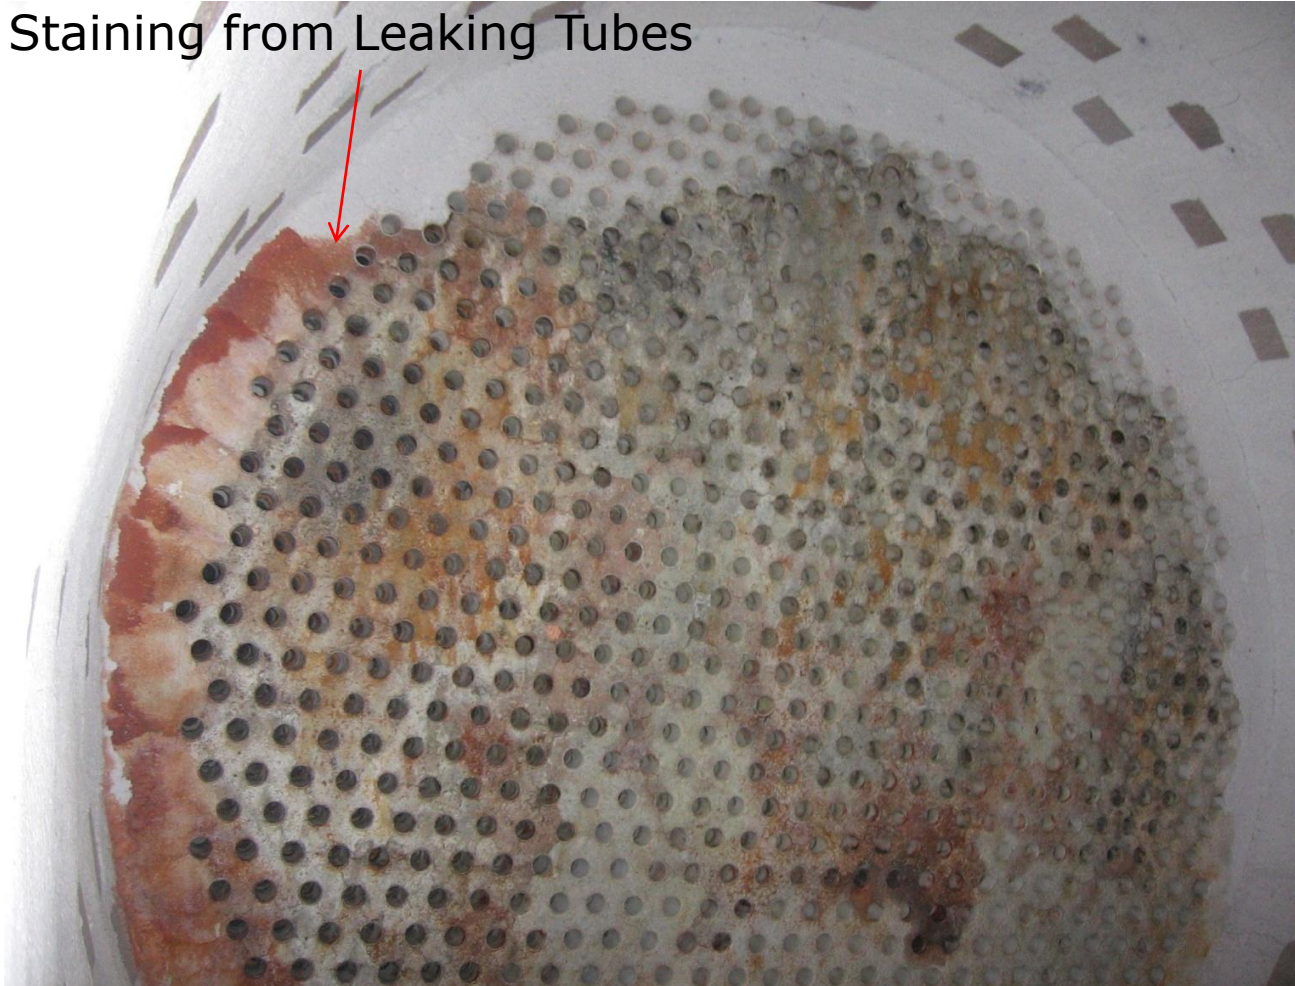
- New firetube style WHB, roughly 3.5 years old
- Sulfur plant shutdown for regular inspection and maintenance.
- Internal inspection of reaction furnace found the checkerwall down, no other significant indication of damage.
- New WHB tubesheet ferrules and refractory appeared to be in good condition
- Upon restart of the unit, attempting PSV lift tests, could not get the boiler pressure to ~200 psig...must be a water leak?
- After re-entry into the reaction furnace...

Staining from Leaking Tubes

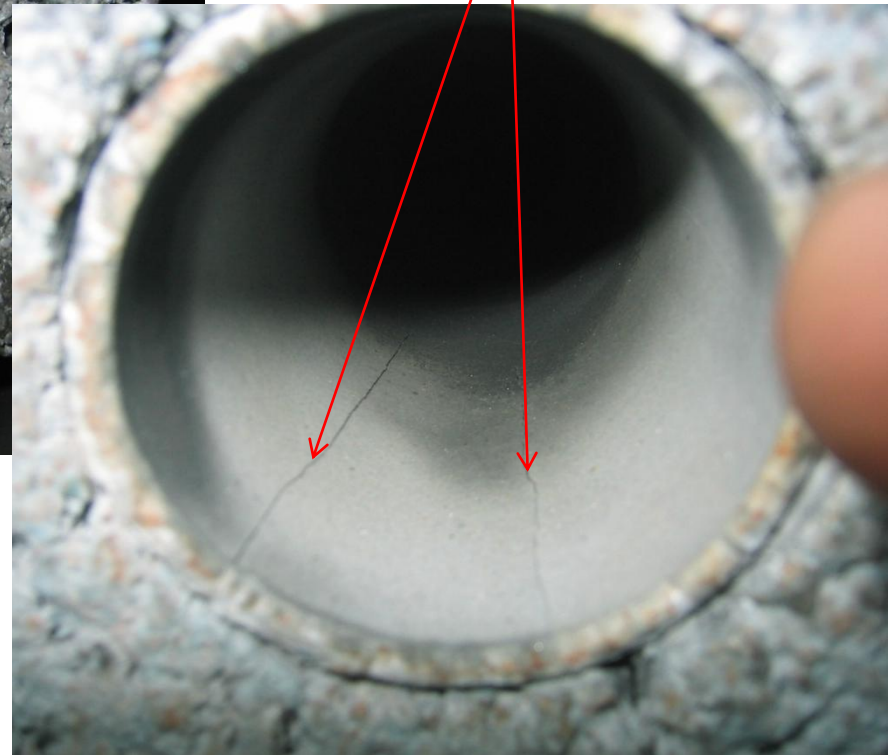
Longitudinal Cracks

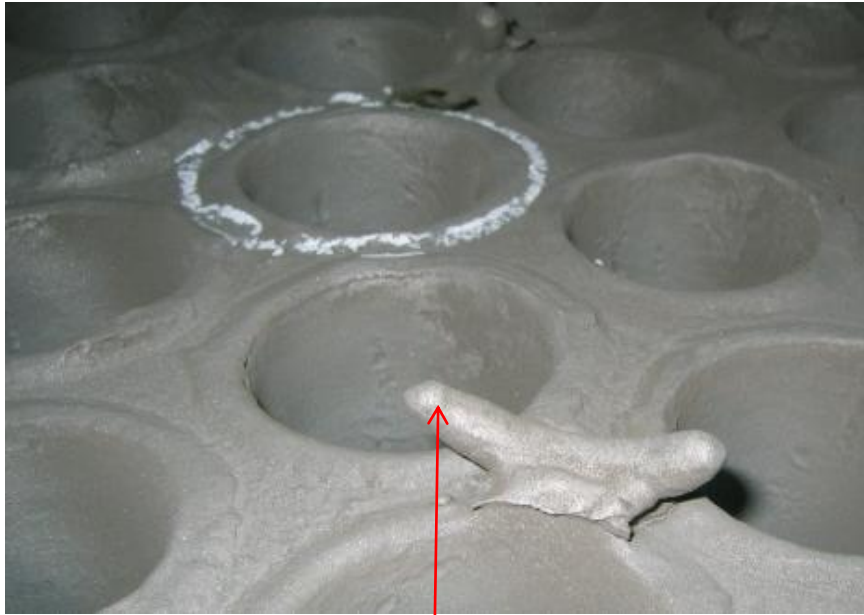
Refractory "V" anchors were 3 inches long.

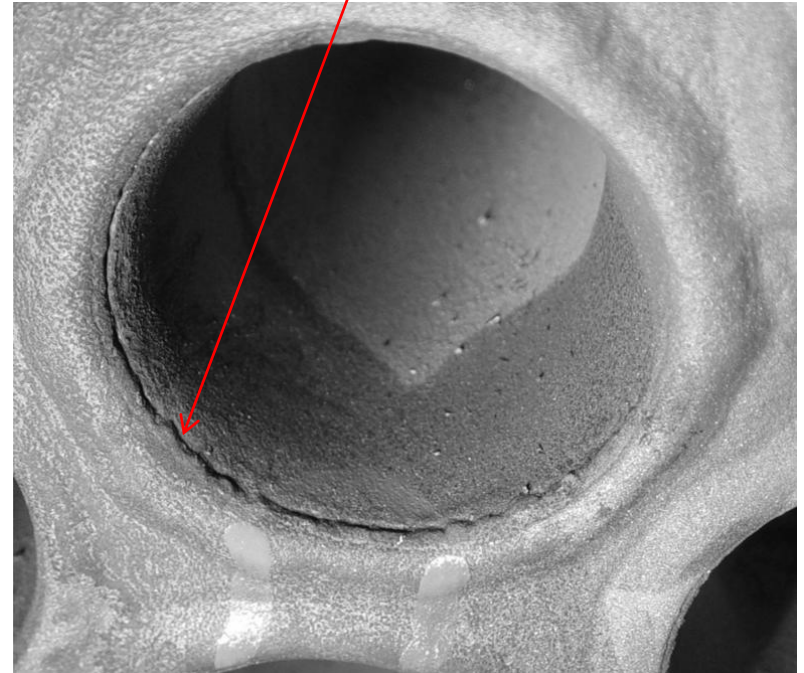
- Cracking at thinned point
- Tubes are 2.25" OD, 8 BWG

- Metallurgical analysis confirmed tubesheet temperature in the range of 700-800°F.
- The refractory anchors may have been on the order of 1000°F.
- The tubes were repaired/replaced and the tubesheet was weld built as required.
- The refractory system was modified to improve the thermal protection.

- Root Cause:
 - Poor thermal design for the tubesheet
 - Convection
 - Radiation (Very important)
- Consider:
 - No indication during operation of a problem
 - No significant indication of a problem upon internal inspection
 - Thermal protection design is very critical and should consider radiation.
 - Inspection should include rigorous inspection of the tubesheet refractory system.

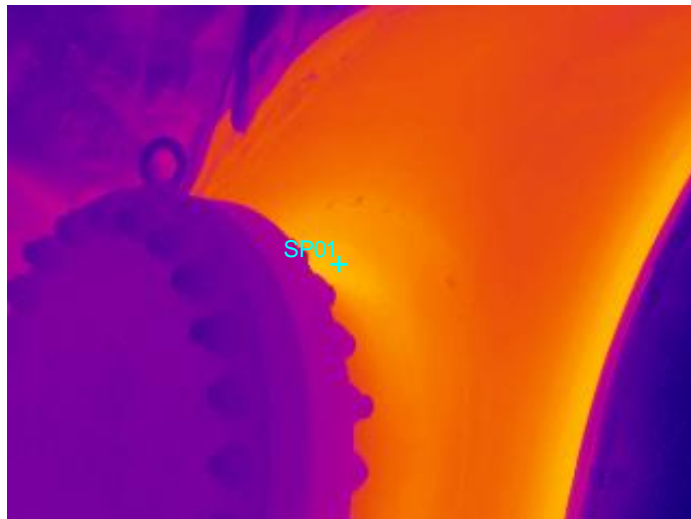
- The "A" unit exchanger is operating with metal temperature around 437°F (225°C)

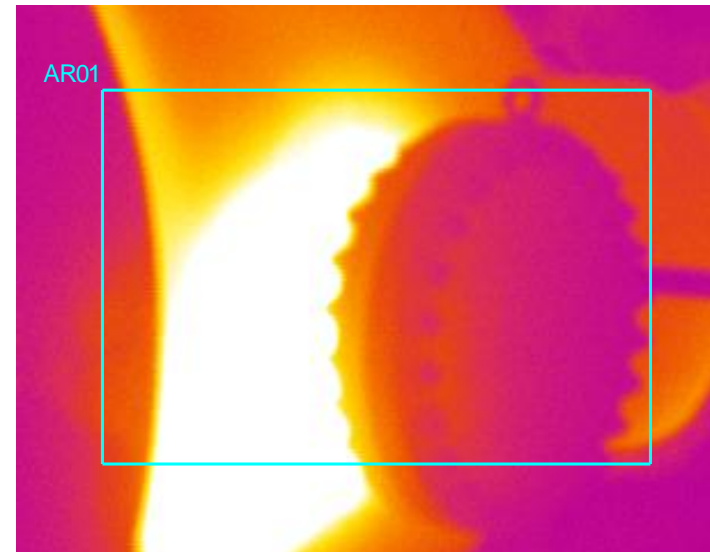
- The "B" unit exchanger is operating with metal temperatures around 1094°F (590°C)!

- At most, based on the inspection schedule, the hot spot could have been present for ~ 6 months.
- The temperature was controlled to roughly 527°F (275°C) using air and steam hoses pointed at the hot spot.
- Subsequent ultrasonic backscatter (AUBT) inspection of the region about 4 months later did not find any damage.
- 3 months later the unit was shutdown again for repairs. Wet fluorescent magnetic particle inspection (WFMPI) was performed on the ID of the channel with no indications found.

- API 941 with 1100°F and 170 psia hydrogen partial pressure predict potential for HTHA
- Modeling and assessment of HTHA damage for the purposes of a fitness for service (FFS) assessment is difficult as there is limited data.
- Work is still ongoing within industry to better model this damage to the point of being able to predict failure, and remaining strength.

- FFS assessment deemed the vessel fit for temporary service with limitations on shutdown and start-up temperatures.
- Subsequent to this assessment, a sample was removed from the affected location and no HTHA was found!
- HTHA has a “sweet spot” temperature.
 - Too high, hydrogen is mobile enough to go right through
 - Too low, not mobile enough for diffusion
