Waste Heat Boilers: FFS Case Histories

Session: Fitness for Service

API Inspectors Summit
Galveston Texas
January 27-30, 2009

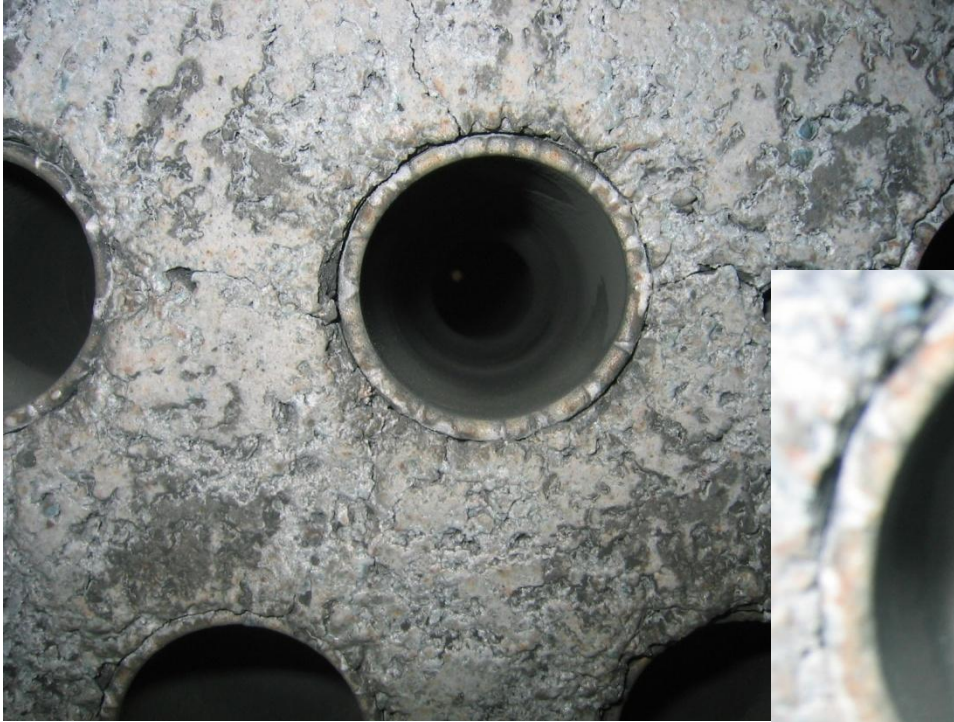
Longitudinal Cracks

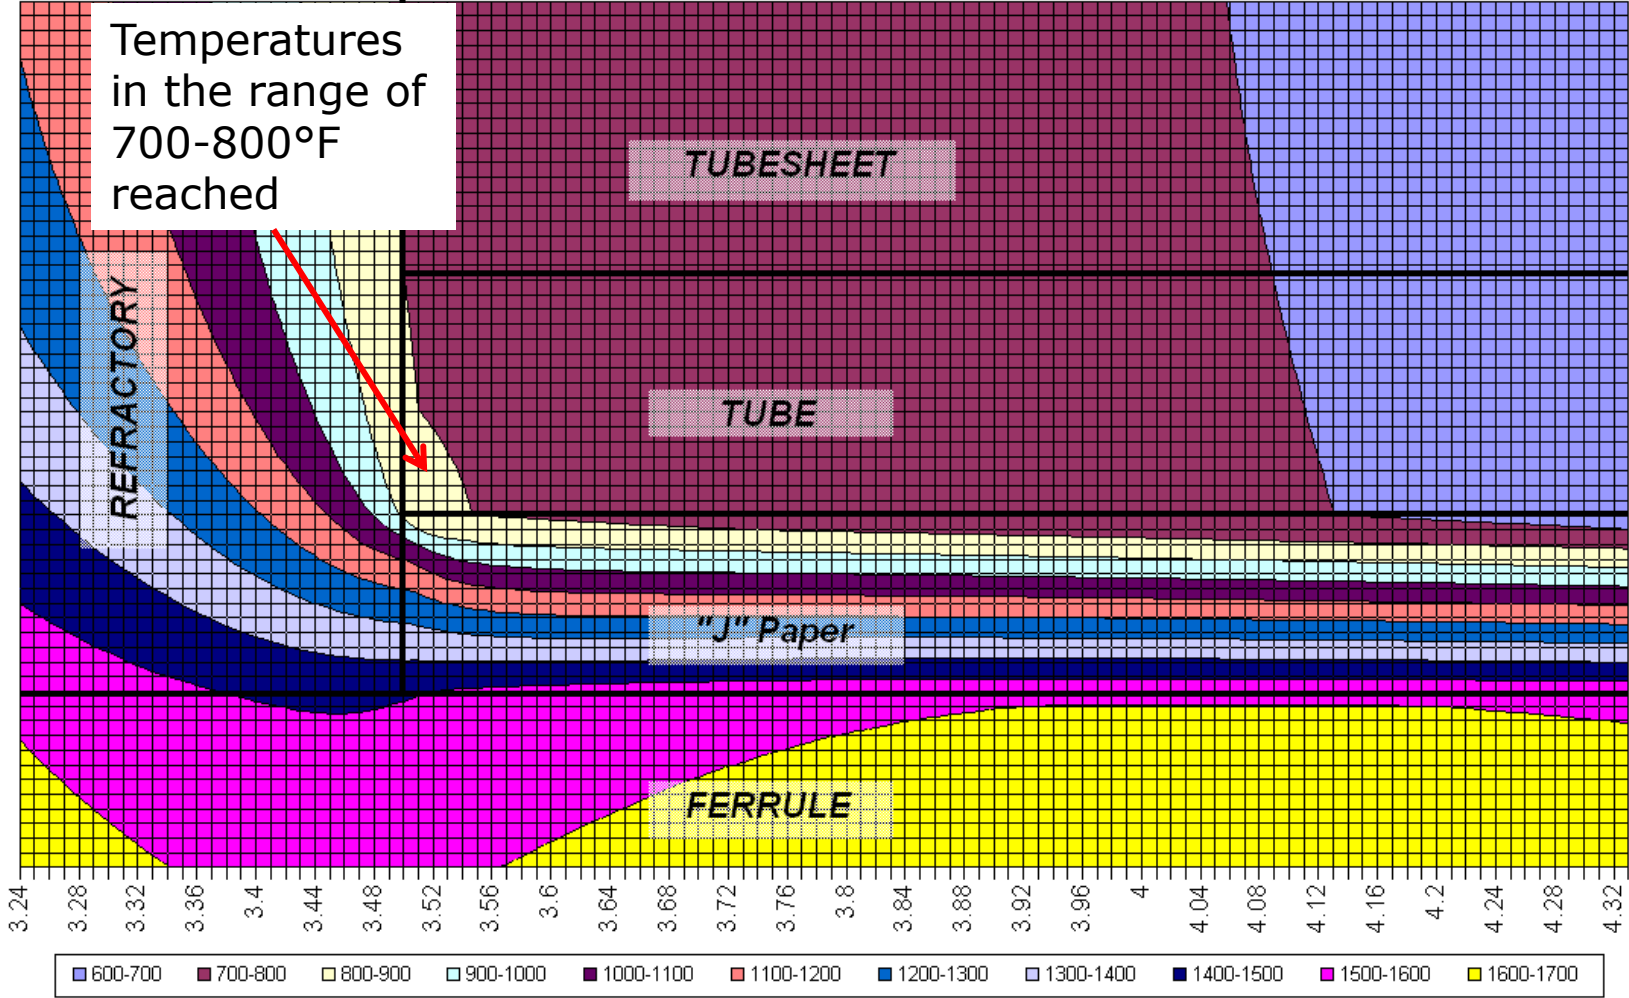
- Metallurgical analysis confirmed tubesheet temperature in the range of 700-800°F.
- The refractory anchors may have been on the order of 1000°F.
- The tubes were repaired/replaced and the tubesheet was weld built as required.
- The refractory system was modified to improve the thermal protection.
